FINAL REPORT
APRIL 1990

REPORT NO. EVT 17-90

COMPARISON OF STANDARD
ISSUE AND ANCRA
INTERNATIONAL MILVAN
RESTRAINT BEAMS IN STATIC
AND DYNAMIC ENVIRONMENTS

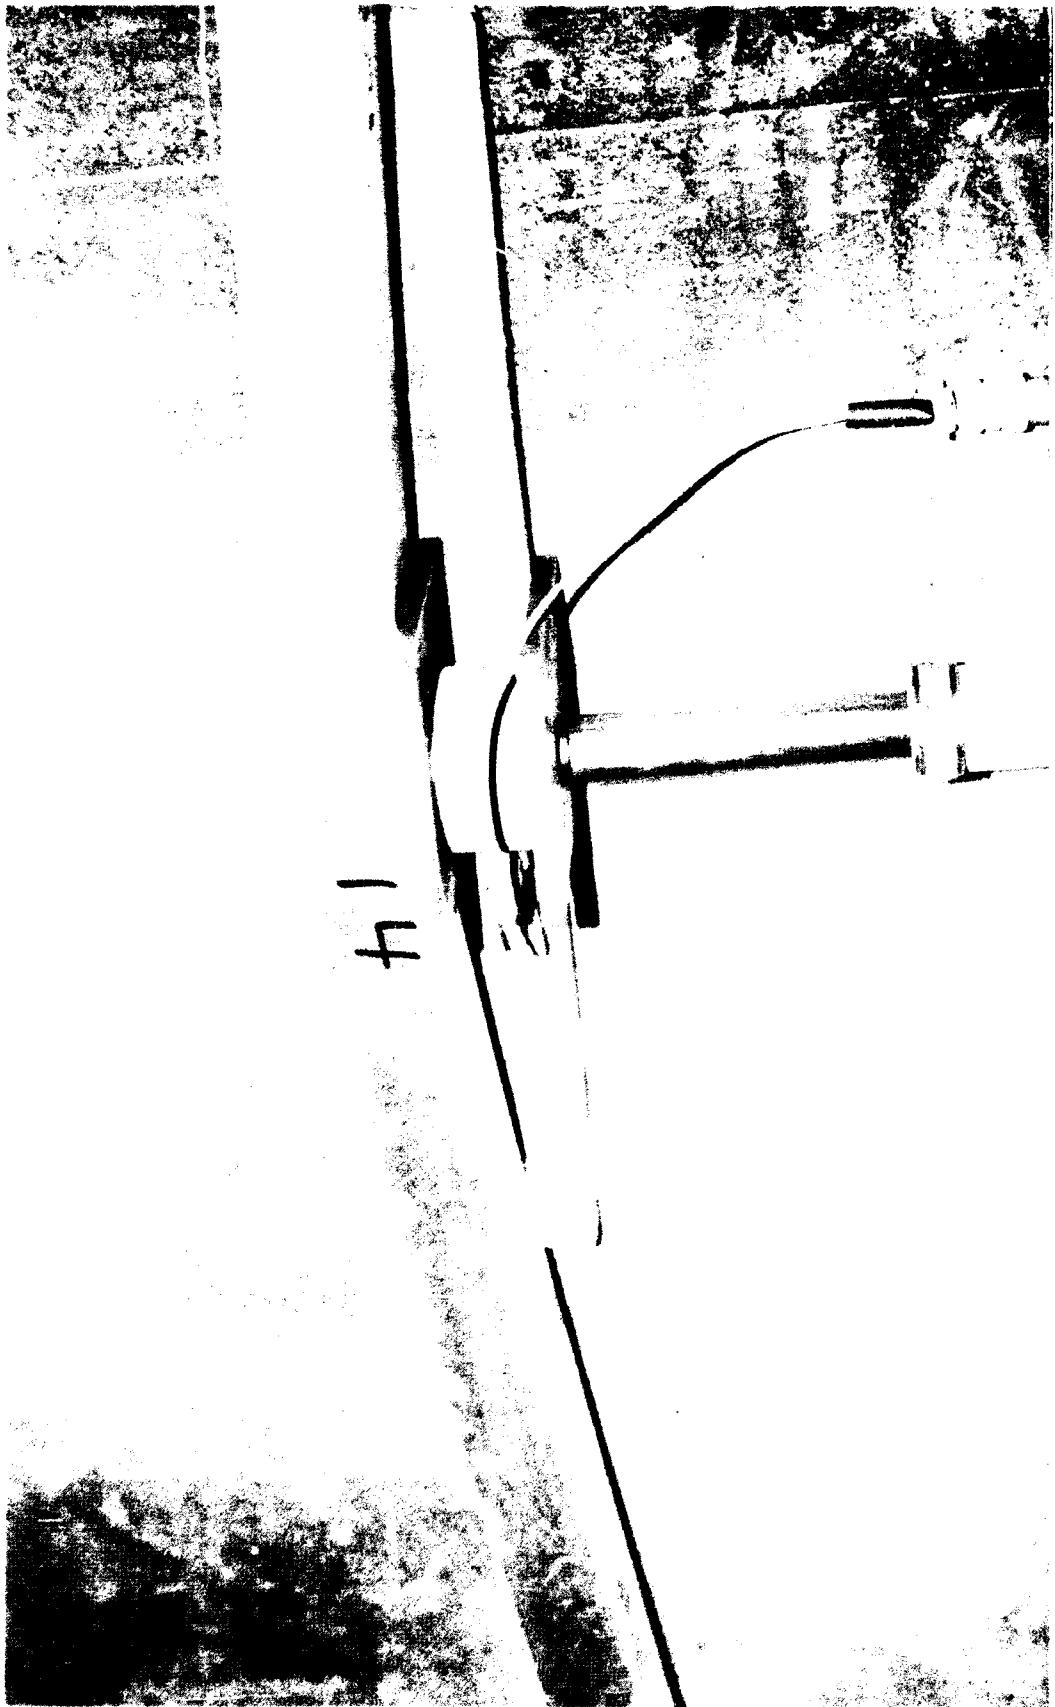
Photo No. A0317-SPN-90-229-3059. This photo shows test sample no. 14 fully loaded. Loading force on the beams increased to a repeated level before failure. After this point, additional load caused increased bending and beam set.

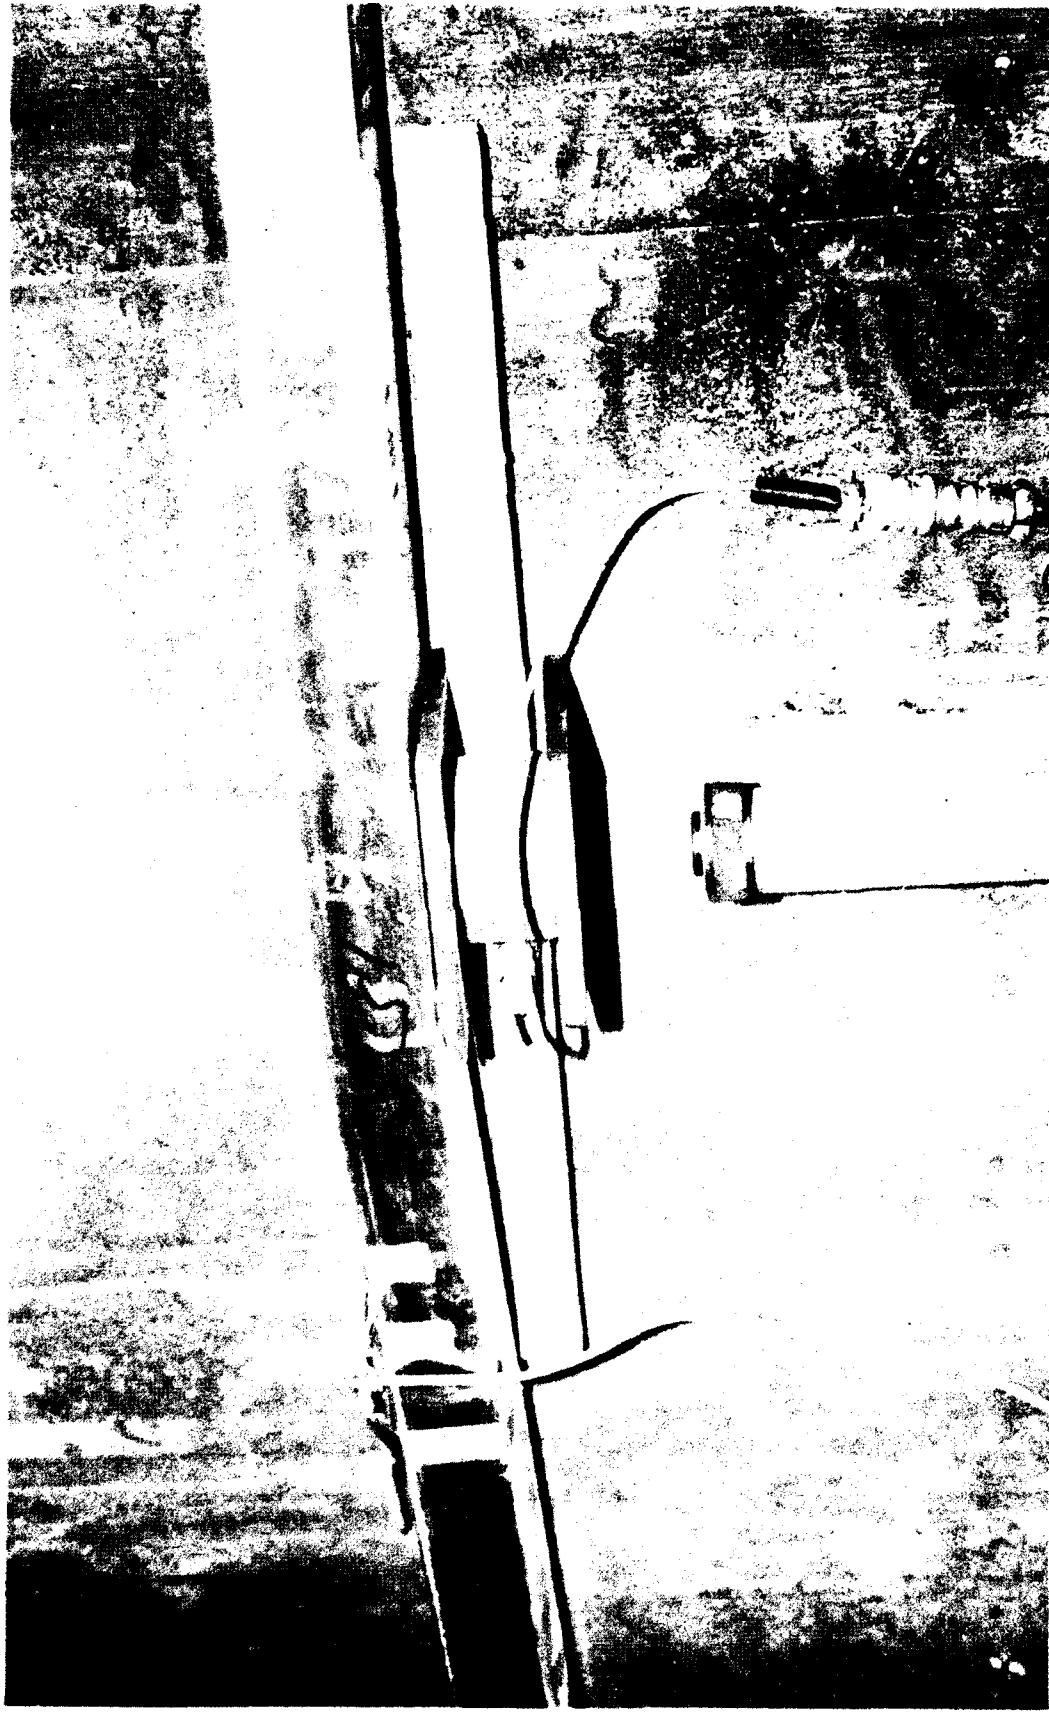
Photo No. A0317-SPN-90-229-3060. This photo shows test sample no. 15 fully loaded. Loading force on the beams increased to a repeated level before failure. After this point, additional load caused increased bending and beam set.

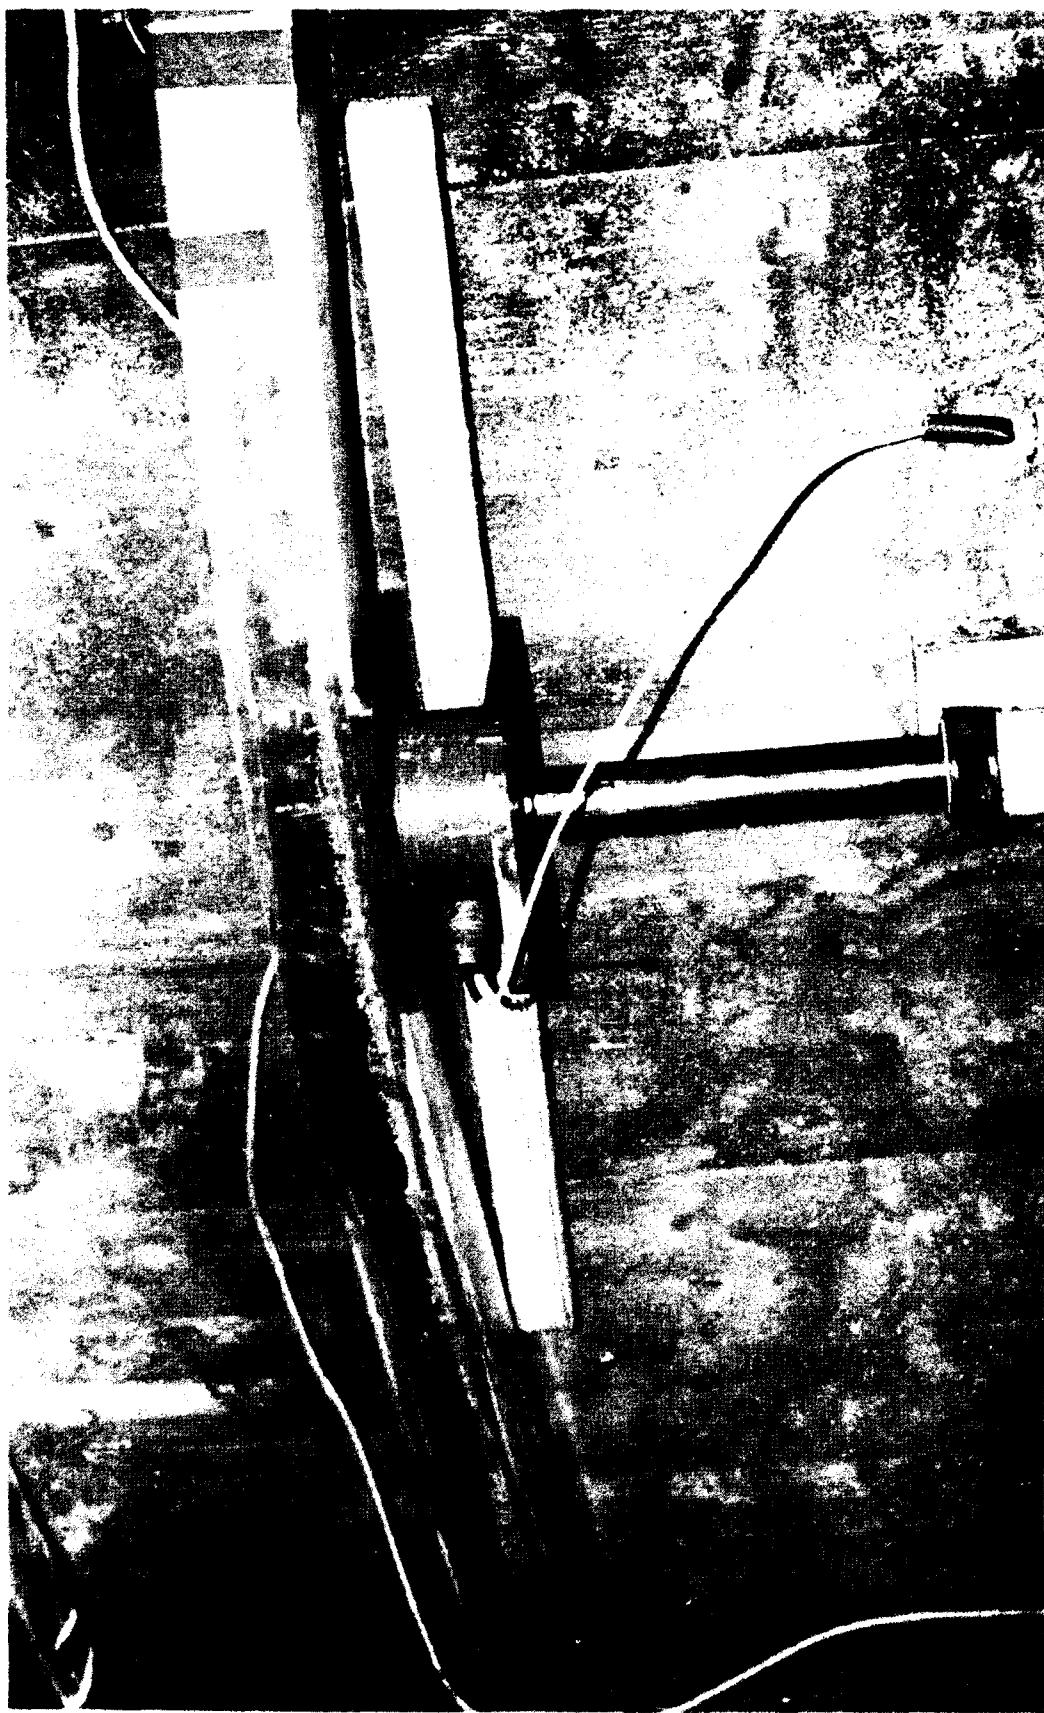
Photo No. A0317-SPN-90-229-3061. This photo shows test sample no. 16 fully loaded. Loading force on the beams increased to a repeated level before failure. After this point, additional load caused increased bending and beam set.

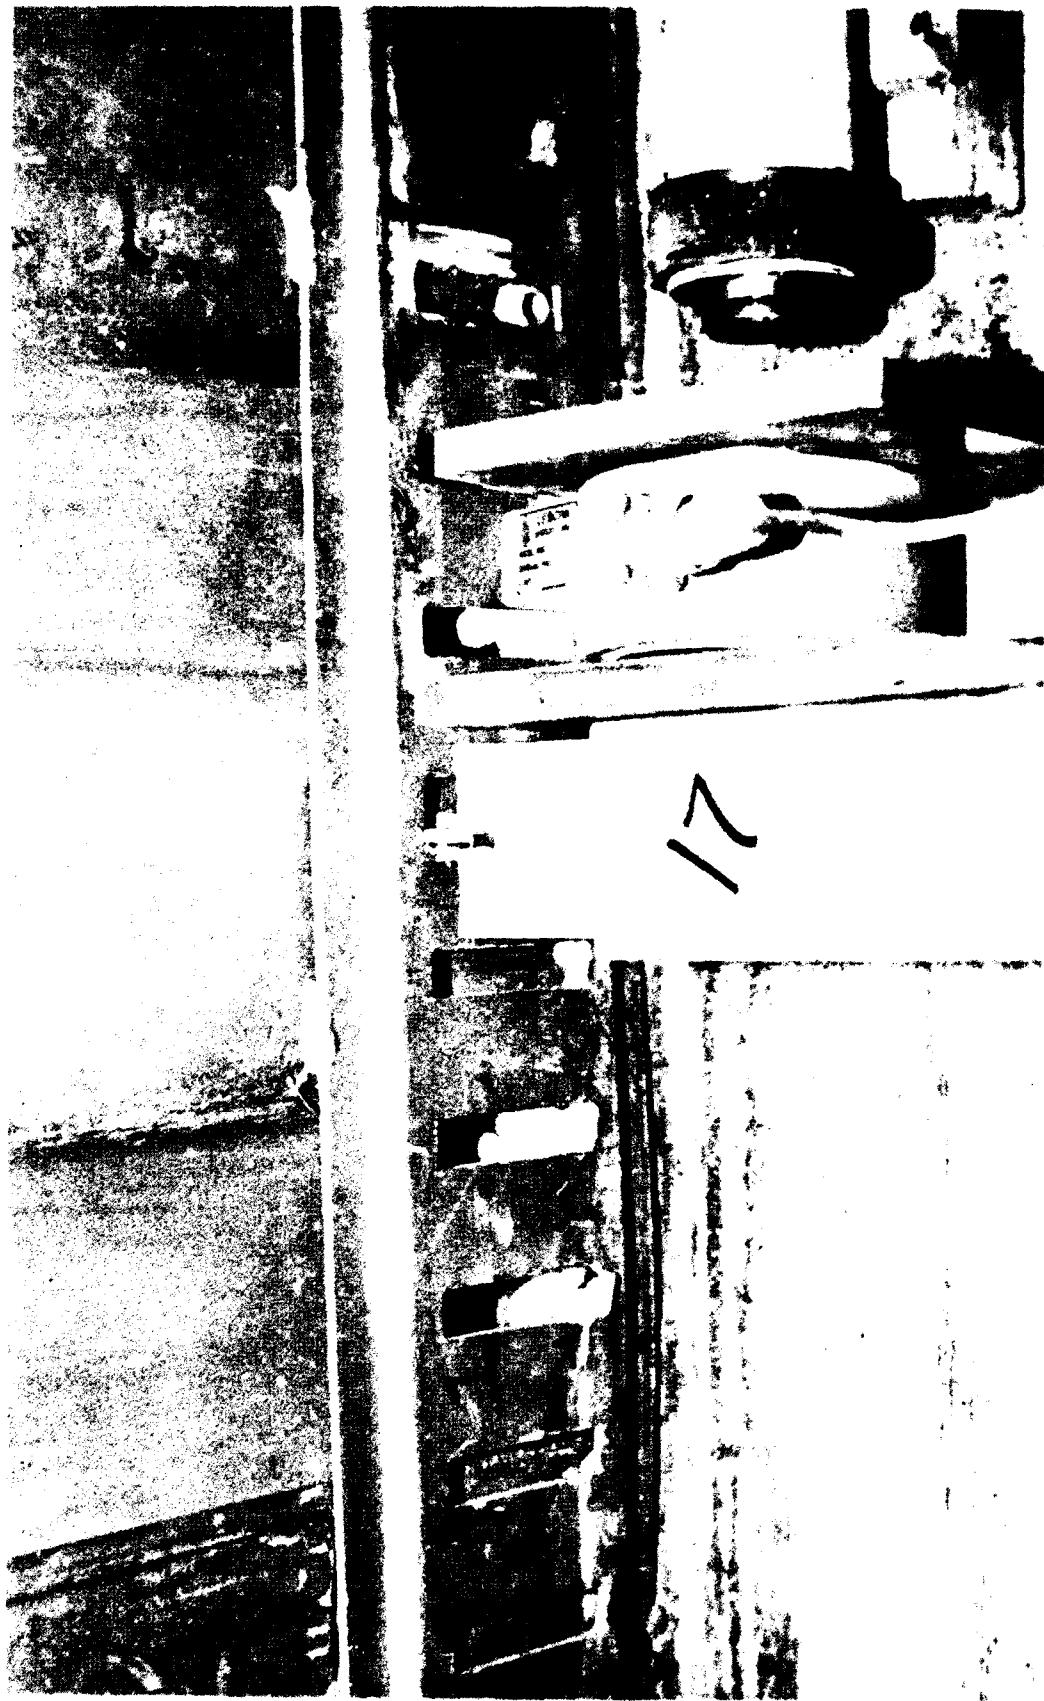
Photo No. A0317-SPN-90-229-3046. This photo shows test sample no. 17. Loading force on the beam was increased until the belt rail cog failed.

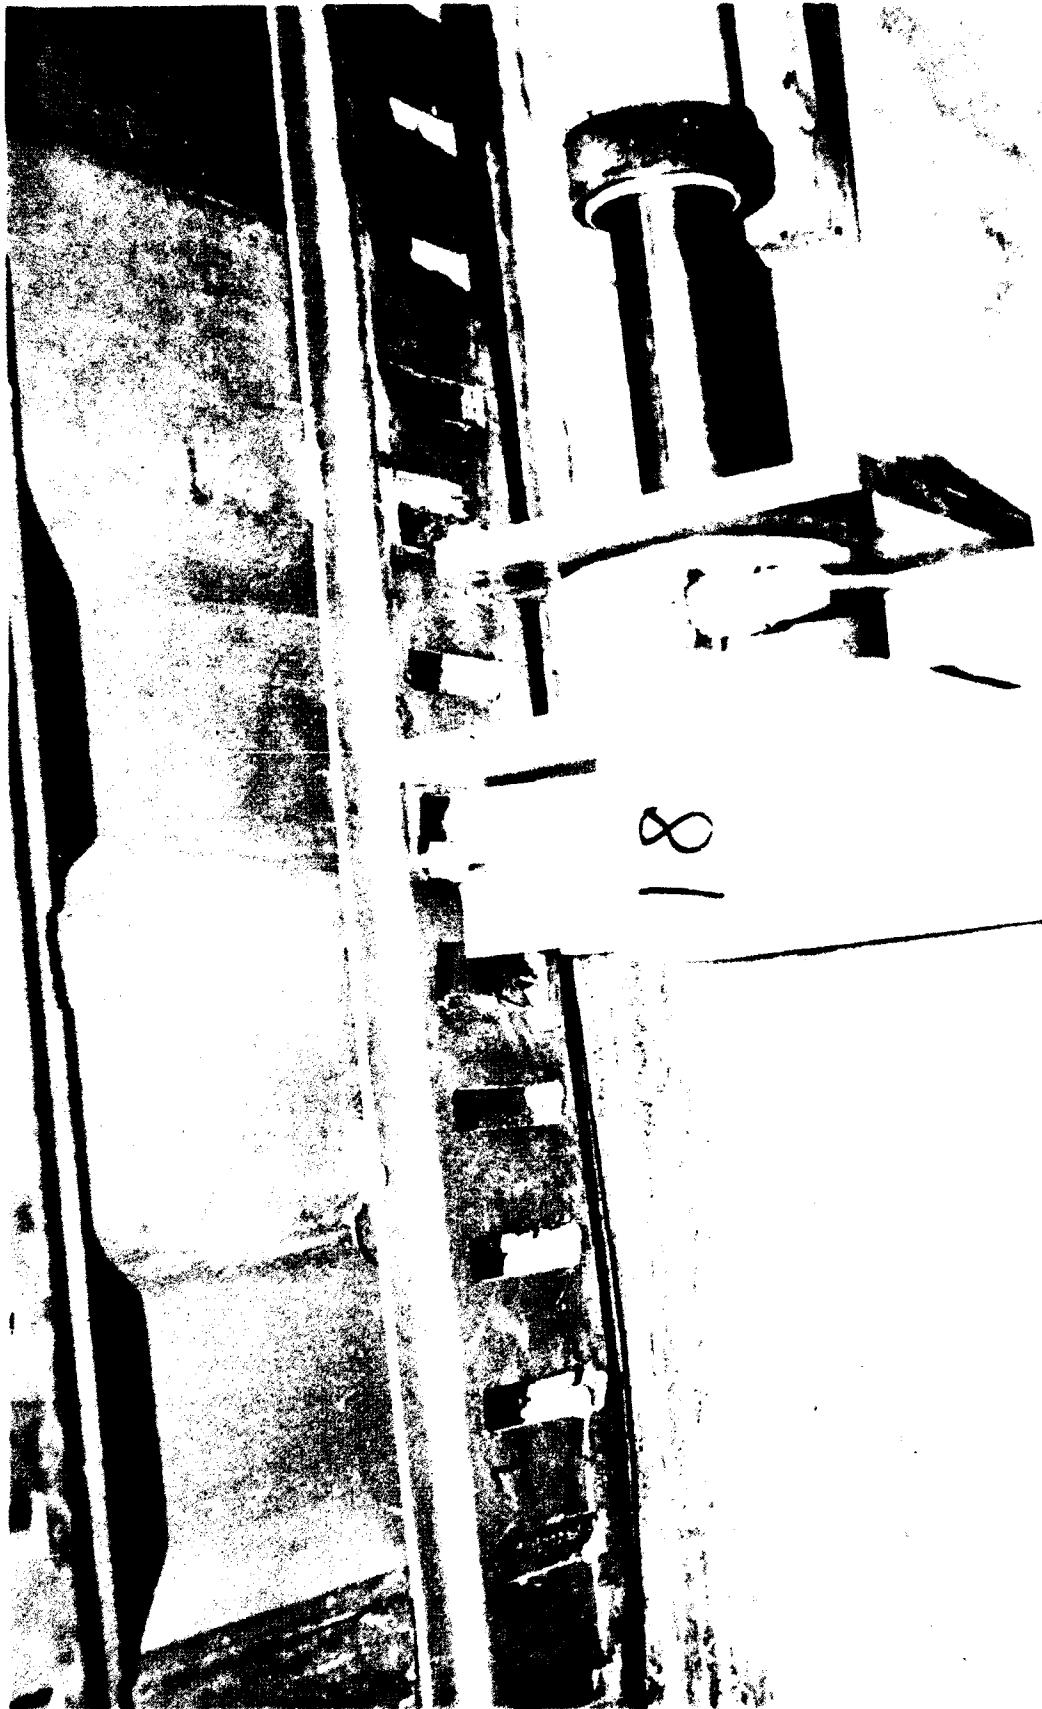
Photo No. A0317-SPN-90-229-3047. This photo shows test sample no. 18. Loading force on the beam was increased until the belt rail cog failed.

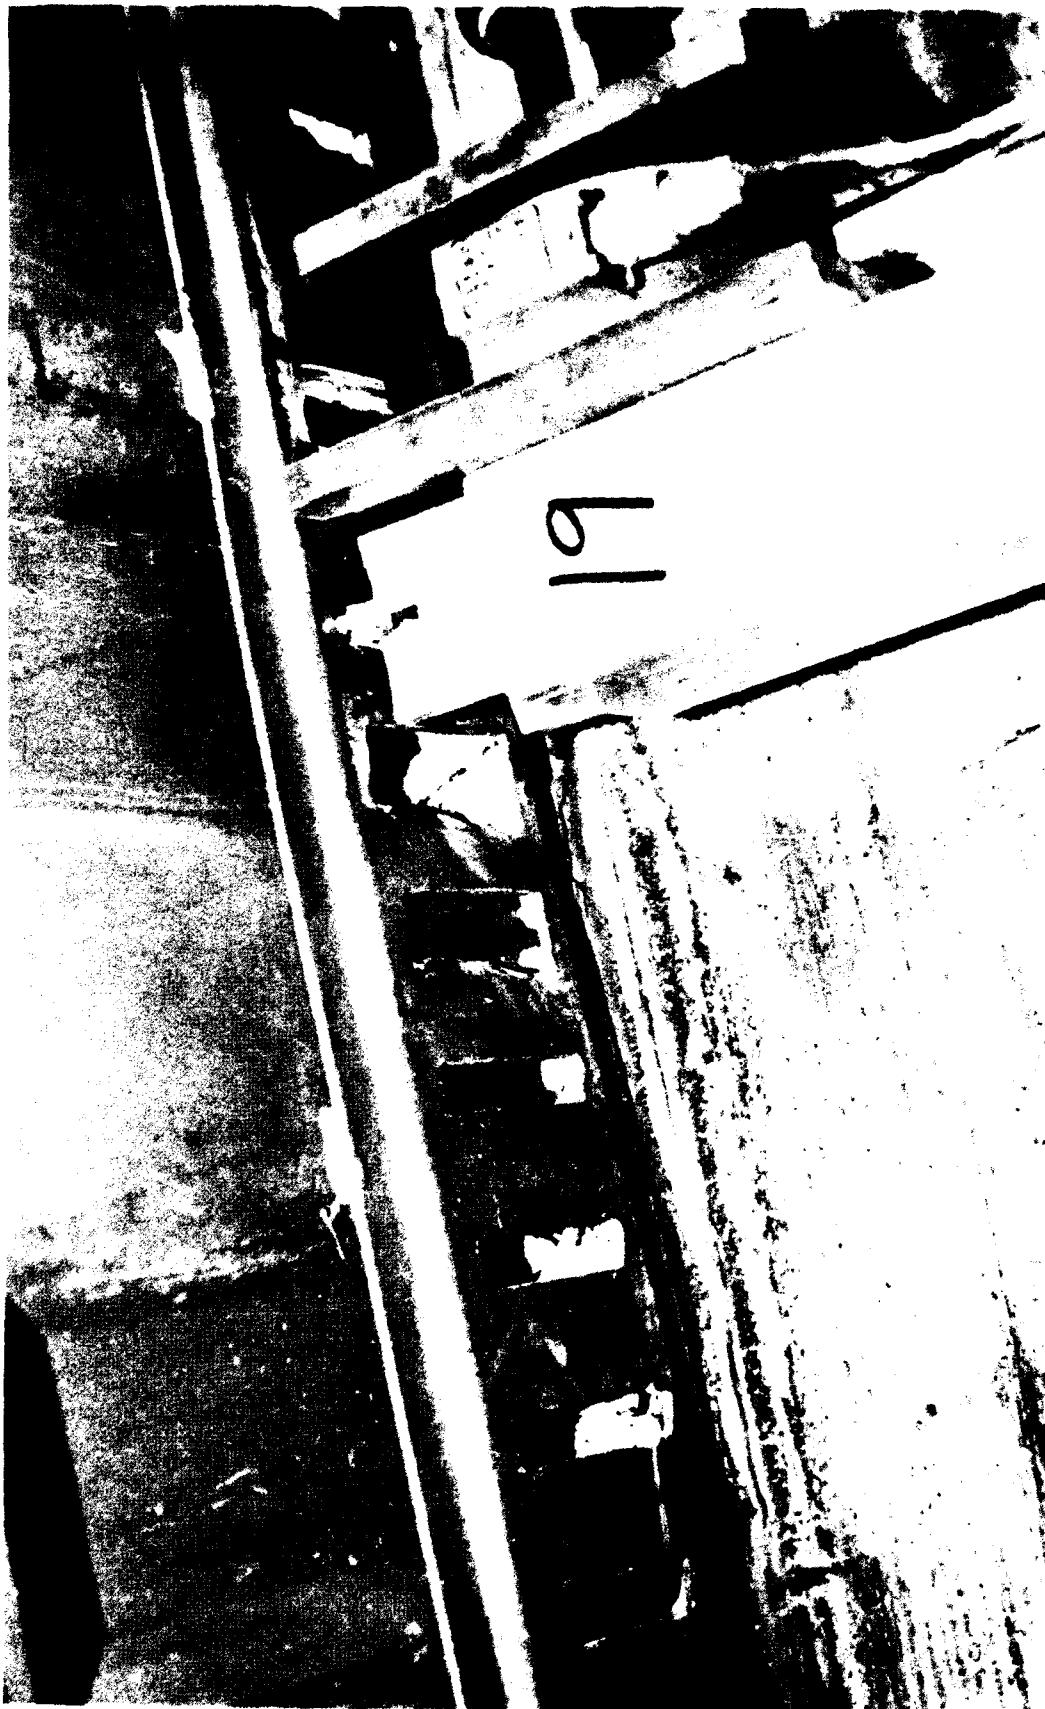
Photo No. A0317-SPN-90-229-3049. This photo shows test sample no. 19 fully loaded. Loading force on the beam was increased until the belt rail cog failed. Note offset in the latch assembly.

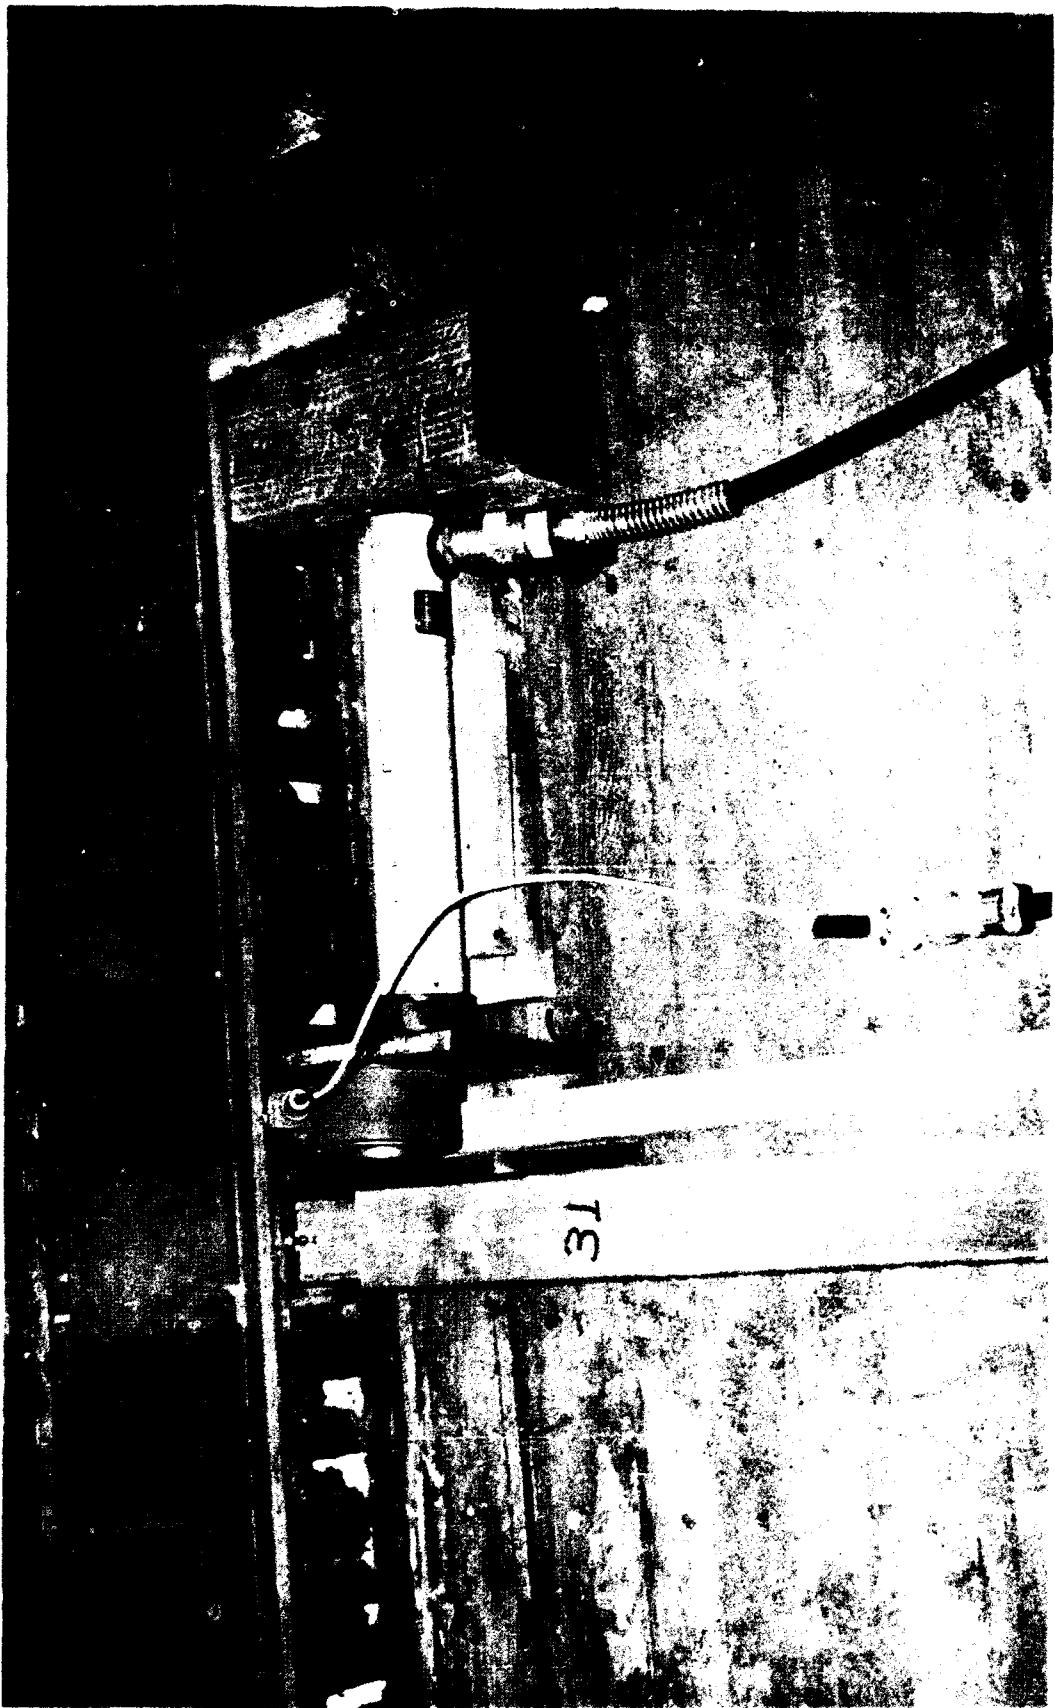
Photo No. SPN-90-229-3083: This photo shows an ANCRA International restraint beam, sample no. 31, prior to performing an end load test.

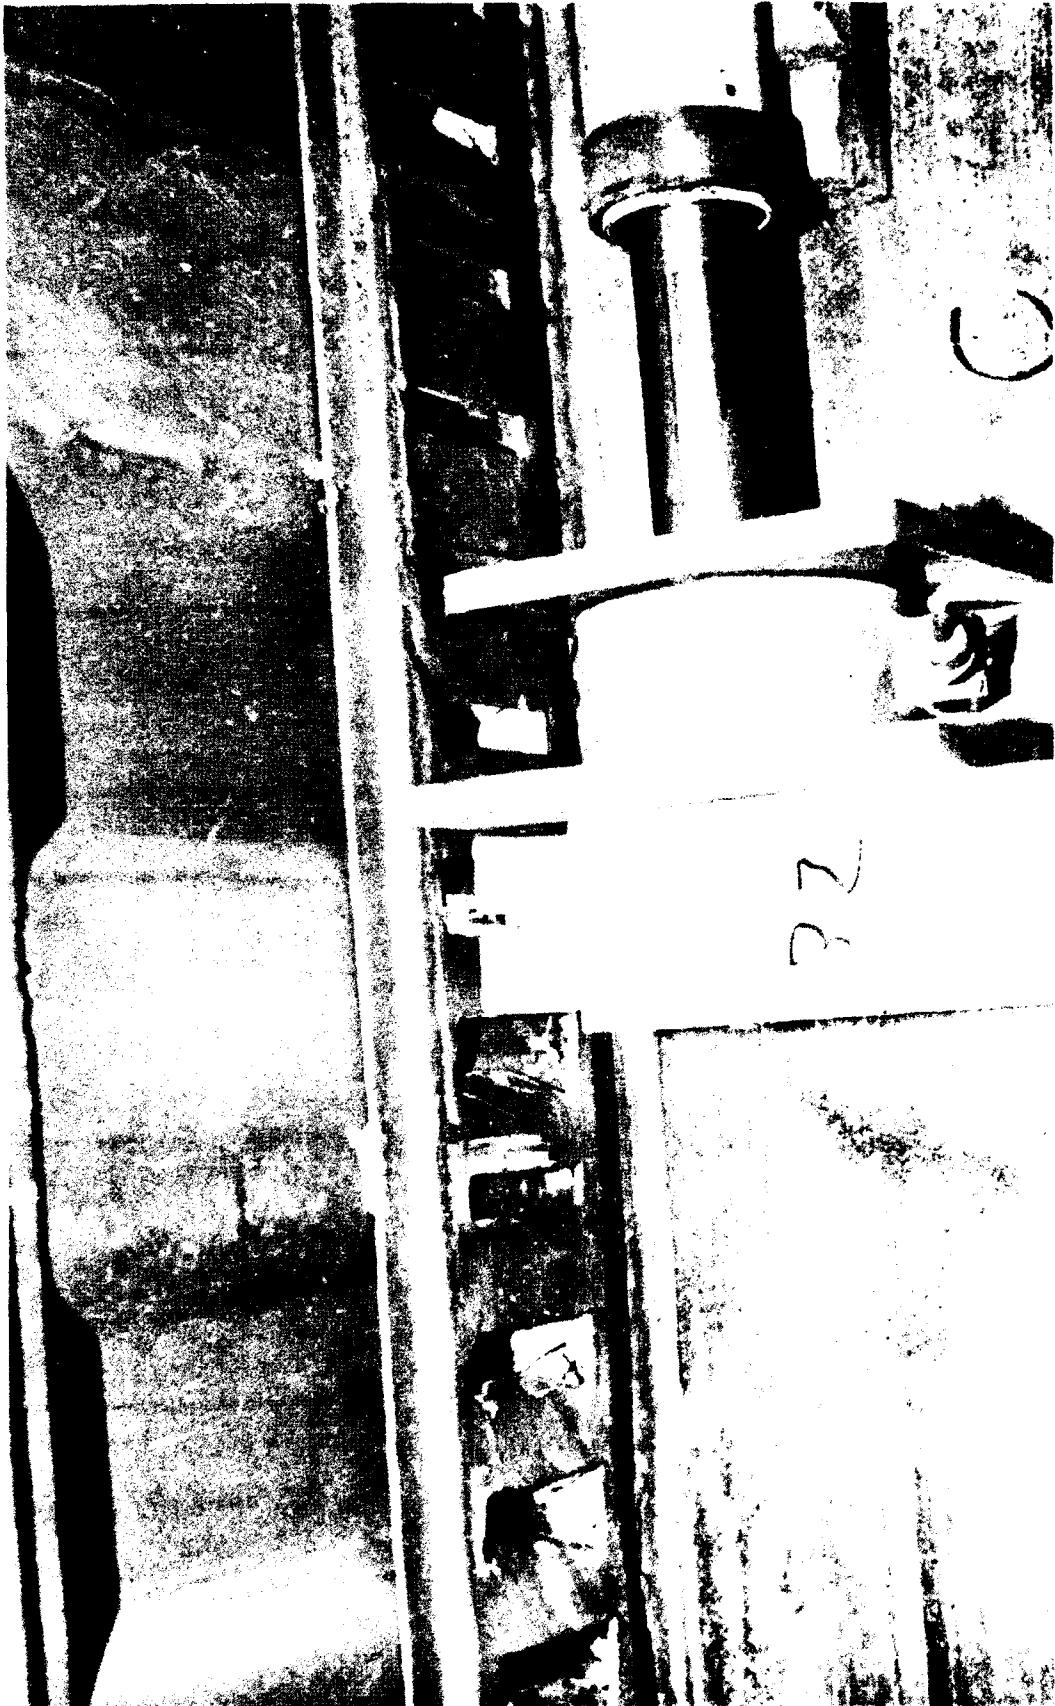
Photo No. SPN-90-229-3086: This photo shows an ANCRA International restraint beam, sample no. 32, with an end load applied to a force just below failure.

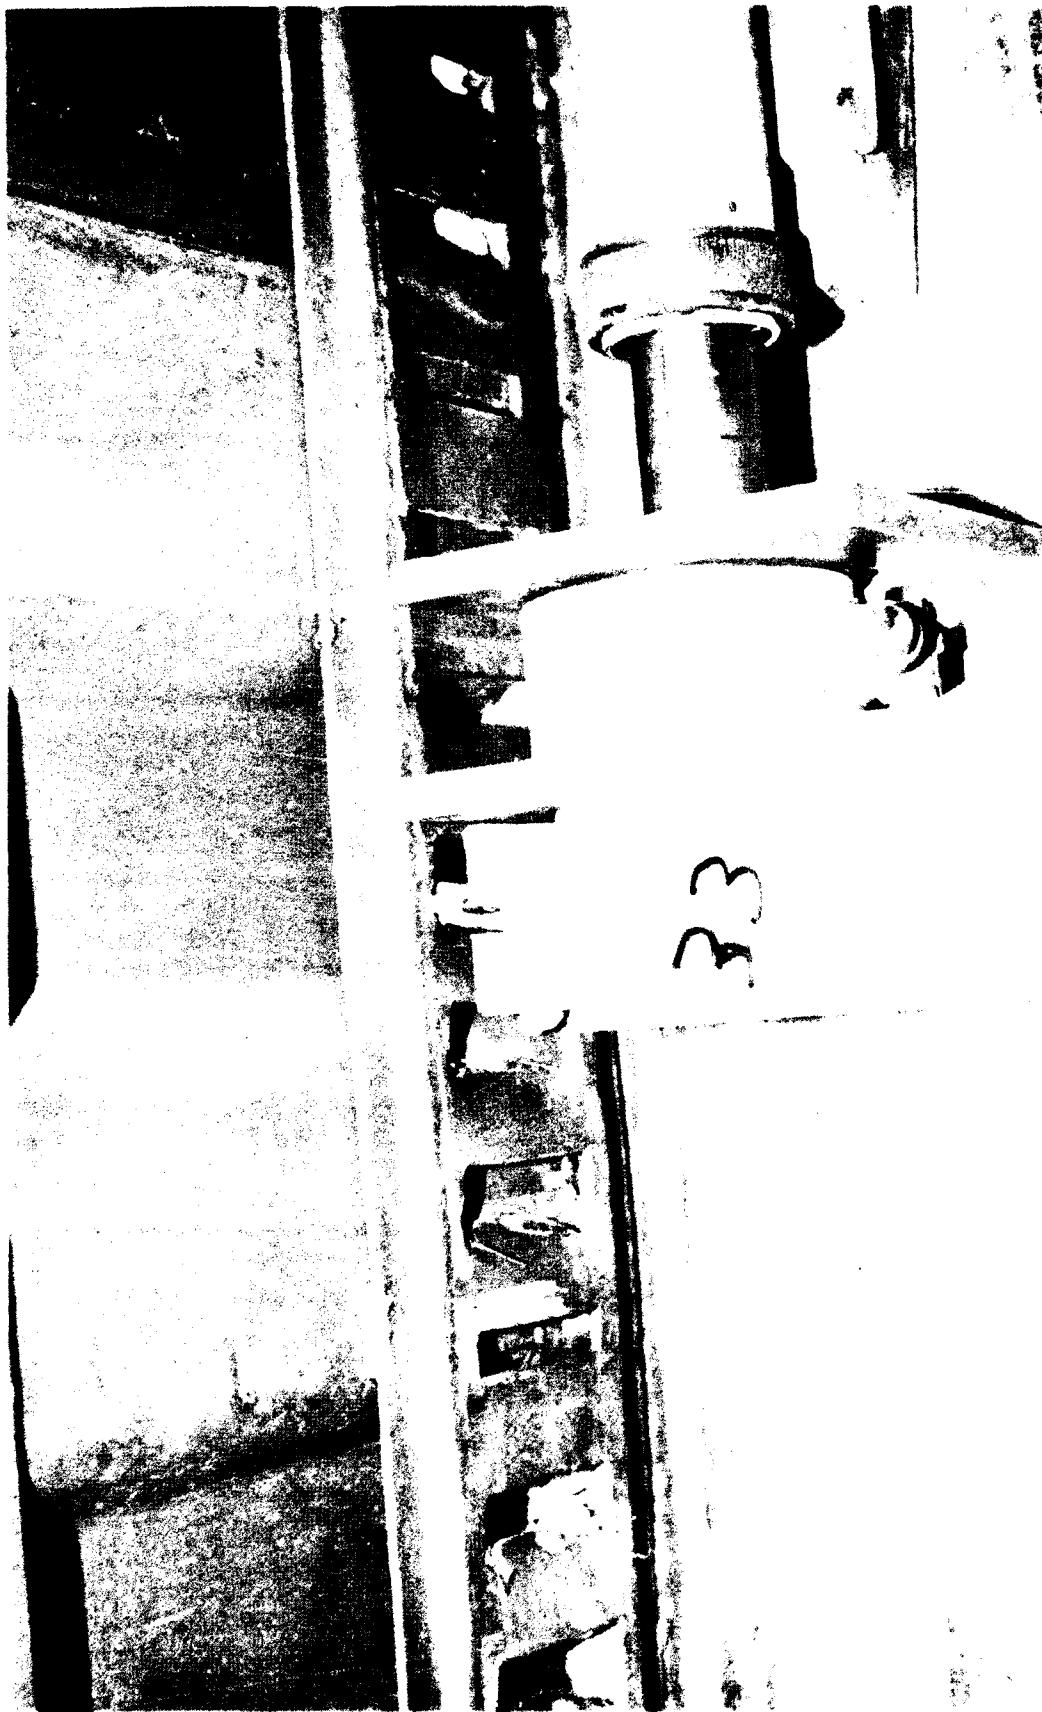
U.S. ARMY DEFENSE AMMUNITION CENTER AND SCHOOL - SAVANNA, IL	Photo No. SPN-90-229-3087: This photo shows an ANCRA International restraint beam, sample no. 33, with an end load applied to a force just below failure.
--	---

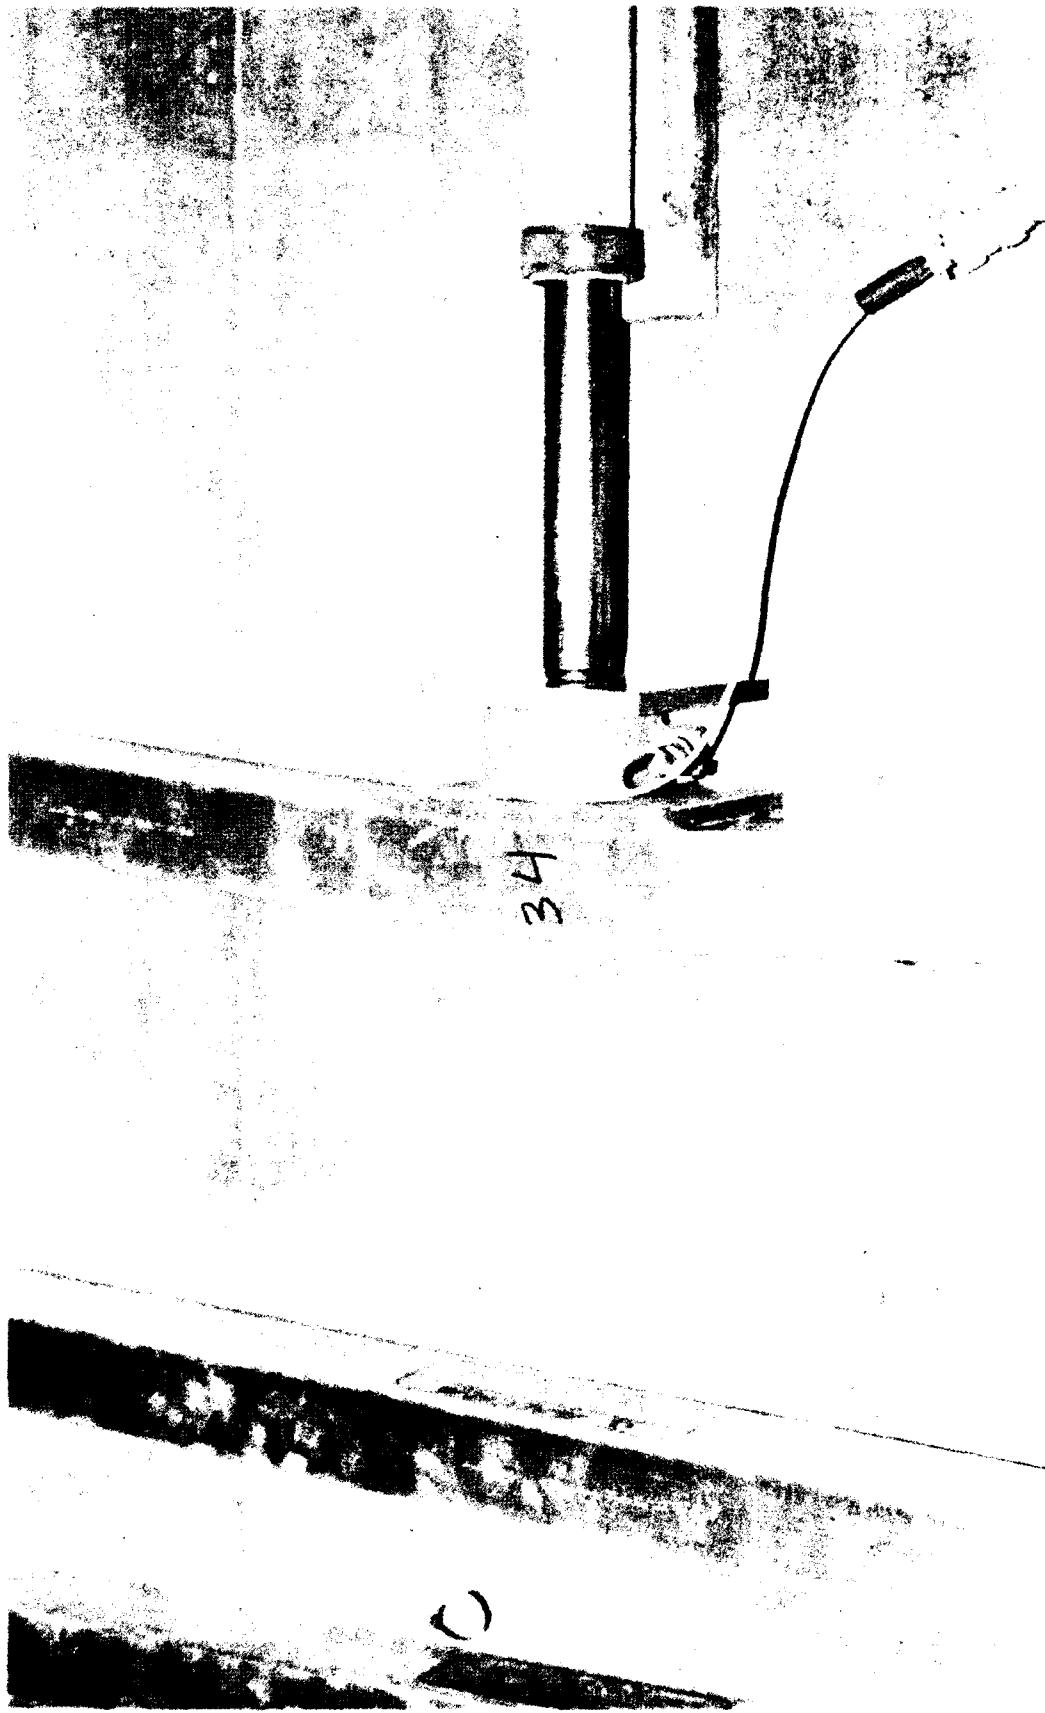
<p>U.S. ARMY DEFENSE AMMUNITION CENTER AND SCHOOL - SAVANNA, IL</p>
	<p>Photo No. SPN-90-229-3089: This photo shows an ANCRRA International restraint beam, sample no. 34, with a point load applied. Failure occurred when the center of the beam started deforming by caving in toward the center line of the beam.</p>

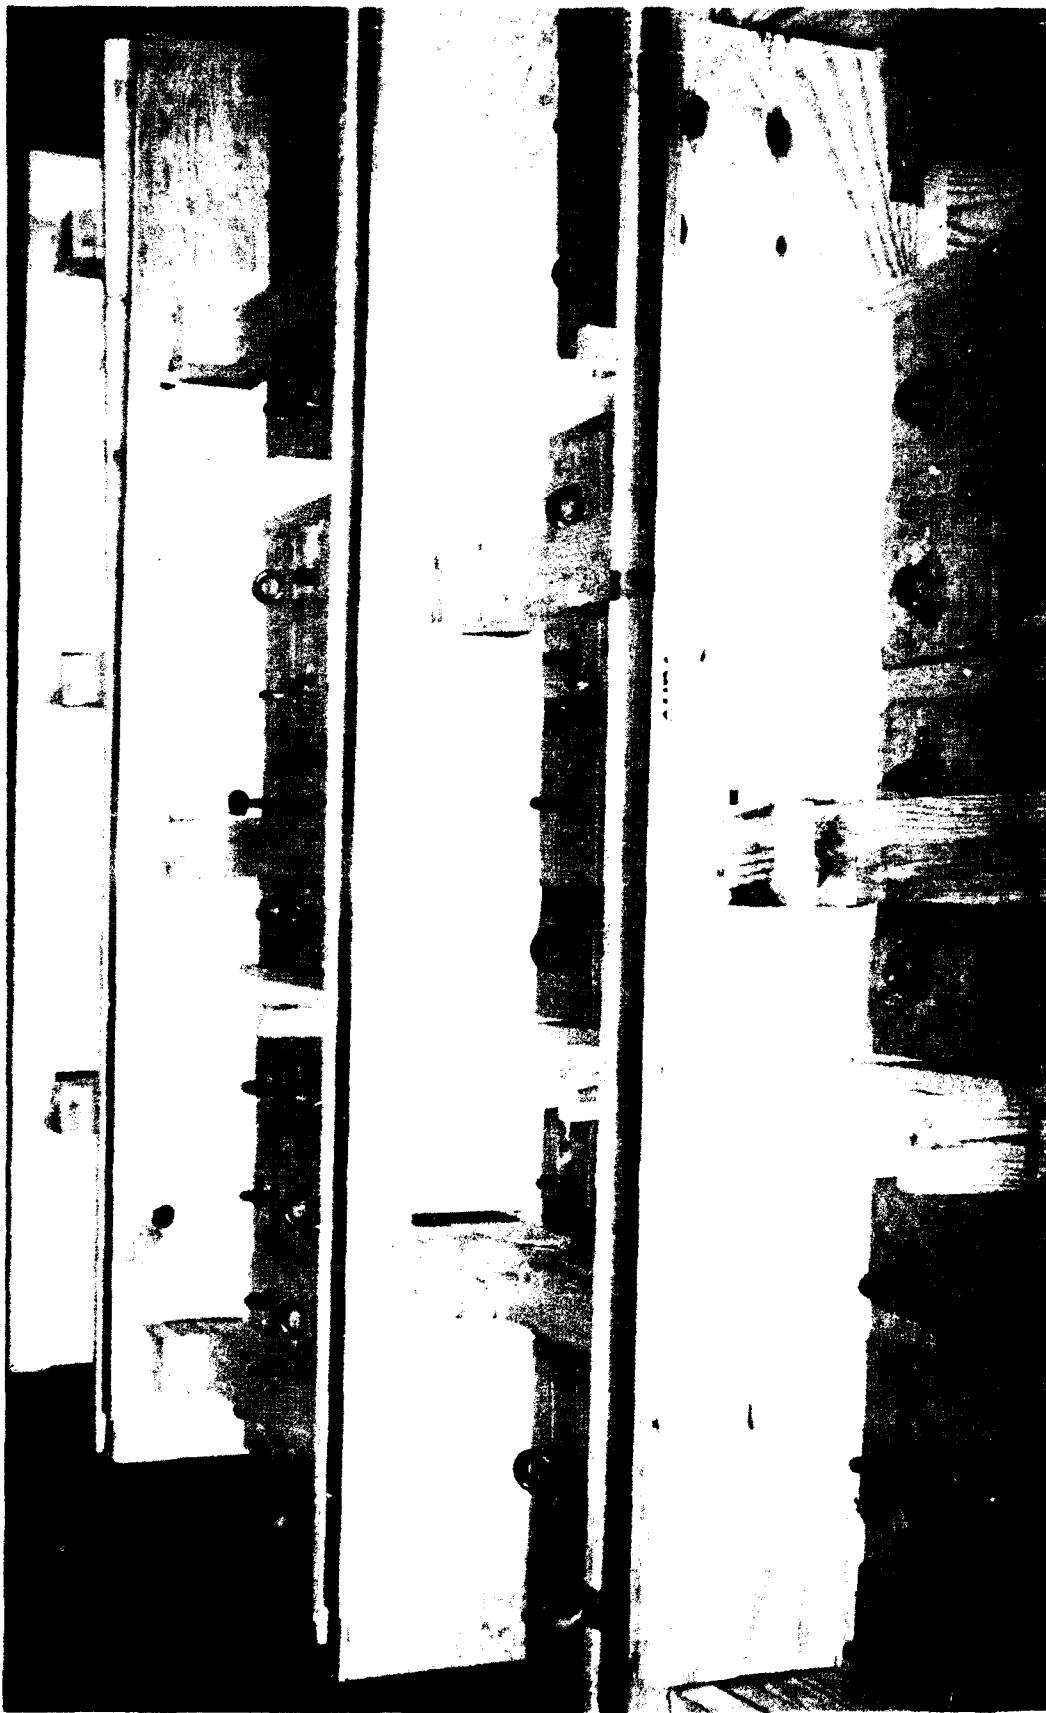
Photo No. A0317-SPN-90-230-3092. This photo shows a MILVAN loaded with inert 155MM ammunition being restrained by ANCRA International beams after rail impact. Note the bow in the restraint beams as compared to the plywood fillers.

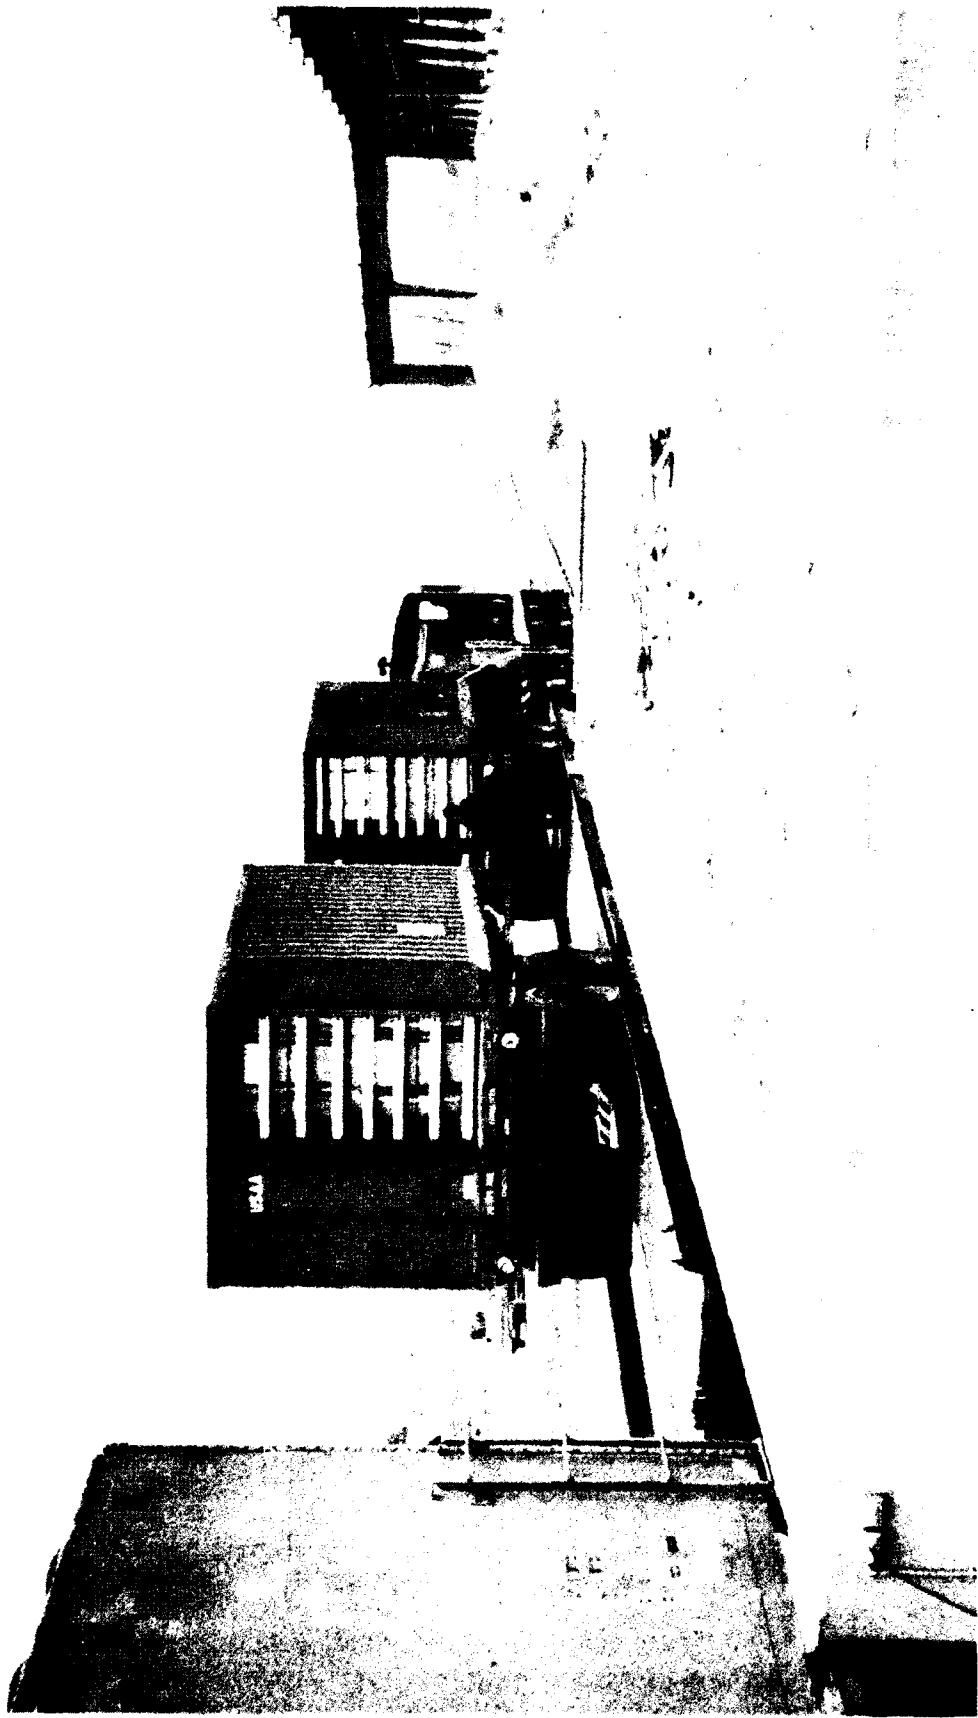
Photo No. A0317-SPN-90-230-3146. This photo shows two MILVANS loaded with inert boxed ammunition being tested for compatibility in the rail mode of transportation. One MILVAN has standard issue restraint beams, the other MILVAN has ANCRA International restraint beams.
